## Slimline® Bedpan Washer Flushometer

### PARTS LIST

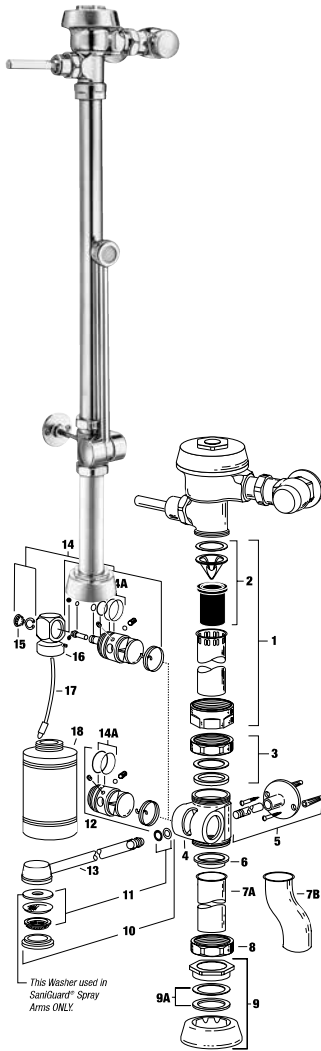
Item No.	Code No.	Part No.	Description
1.	<b>0393009</b>	V-600-AA	1-1/2" x 21-1/2" CP Vacuum Breaker
	<b>0393008</b>	V-600-AA	1-1/2" x 13-1/2" CP Vacuum Breaker (ADA height)
	<b>0393029</b>	V-600-AA	1-1/2" x 21-1/2" CP Vacuum Breaker w/2" Offset

2.	<b>3323182</b>	V-651-A	Vacuum Breaker Repair Kit
3.	<b>0306093</b>	F-2-A	1-1/2" Slip Joint Coupling
4.	<b>0309001</b>	DV-1	Diverter Valve Body (non-Deoseptic bottle)
	<b>0309052</b>	DV-17	Diverter Valve Body (Deoseptic bottle)

5.	<b>3309035</b>	DV-1001-A	Wall Support Kit
6.	<b>0309027</b>	F-1003	Outlet Tube Gasket – for Flanged Tubes only
7A.	<b>0309029</b>	F-1005	Outlet Tube
7B.	<b>0396525</b>	F-182	Outlet Tube w/1-1/2" Offset

8.	<b>0306045</b>	F-2	1-1/2" Coupling Nut
9.	<b>0306146</b>	F-5-A	1-1/2" Spud Coupling Assembly
9A.	<b>SEE SLIP JOINT GASKETS AND RINGS TABLE ON BOTTOM, PAGE 30</b>

10.	<b>3309044</b>	DV-32-AA	12" Spray Arm Replacement Kit
	<b>3309077</b>	DV-1014-A	Short Spray Arm Replacement Kit (for use with F-182 Offset Outlet Tube)

11.	<b>3309032</b>	DV-1007-A	Spray Arm Repair Kit
12.	<b>3309037</b>	DV-1003-A	Pivot Replacement Kit
—	<b>0309021</b>	DV-55-A	Diverter Valve Assembly and 12" Spray Arm Assembly includes: 3, 4, 8, 10, 12
—	<b>0309022</b>	DV-69-A	Diverter Valve Assembly and 10" Spray Arm Assembly includes: 3, 4, 8, 10, 12

13.	<b>3309015</b>	DV-1017-A	Repair Kit 15" SaniGuard® Spray Arm

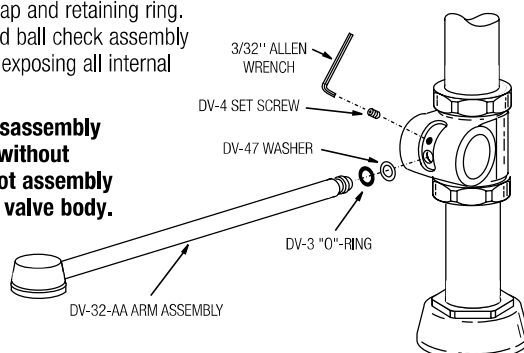
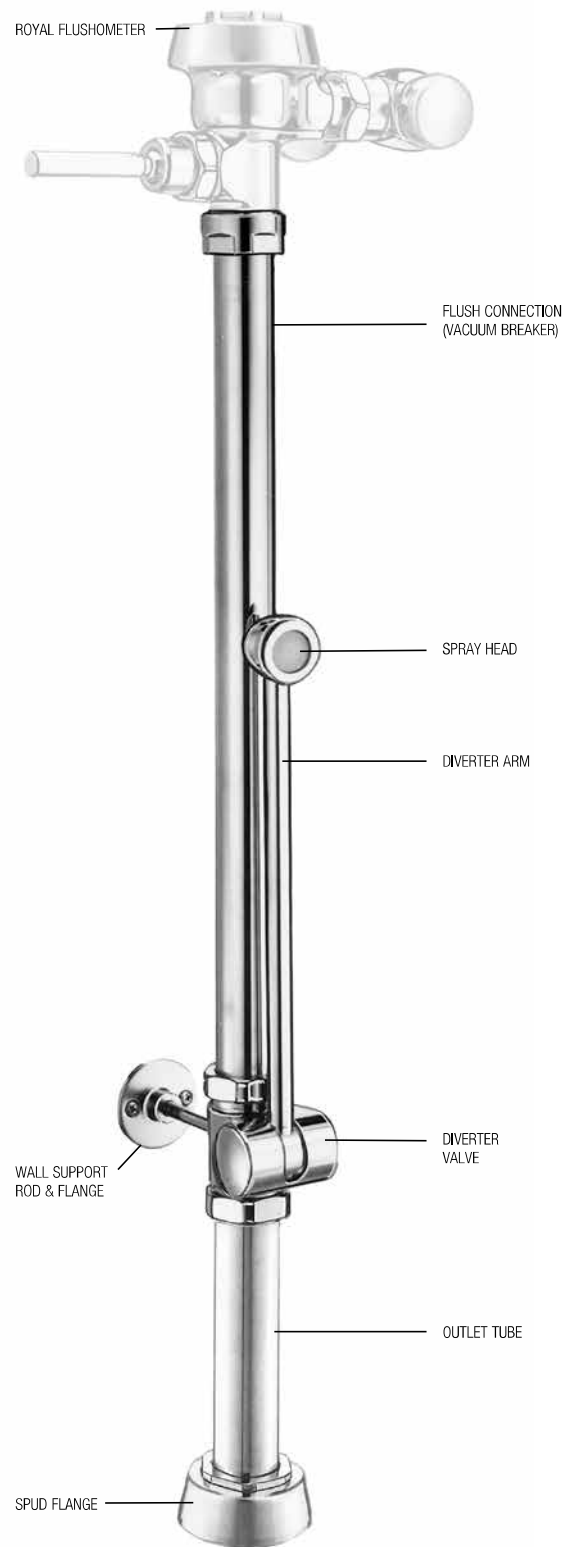
### REBUILDING THE SLOAN SLIMLINE DIVERTER ASSEMBLY:

**To disassemble diverter valve:** Loosen set screw and remove spray arm from pivot. Slide pivot out of diverter valve body.

#### To further disassemble deoseptic diverters:

Remove plug cap and retaining ring. Slide swivel and ball check assembly off pivot shaft, exposing all internal components.

**NOTE: This disassembly can be done without removing pivot assembly from diverter valve body.**

#### REBUILDING THE SLOAN SLIMLINE DIVERTER ASSEMBLY:

**To disassemble diverter valve:** Loosen set screw and remove spray arm from pivot. Slide pivot out of diverter valve body.

#### To further disassemble deoseptic diverters:

Remove plug cap and retaining ring. Slide swivel and ball check assembly off pivot shaft, exposing all internal components.
